POPPLETON HISTORIC STUDY

855-869 W. Lombard Street

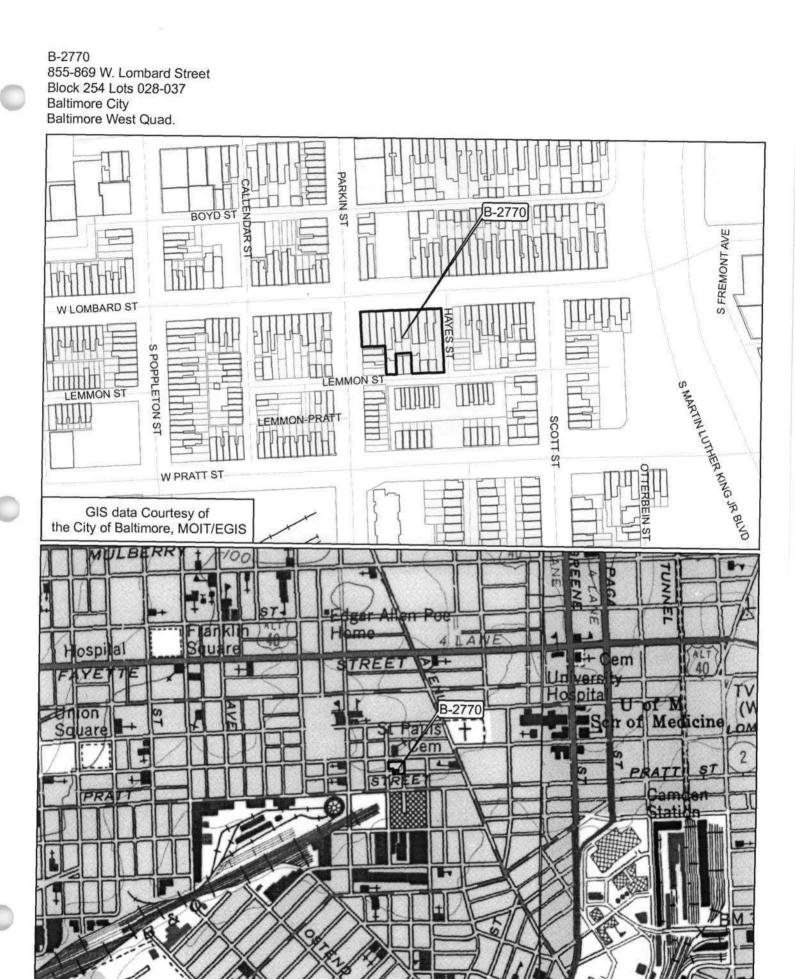
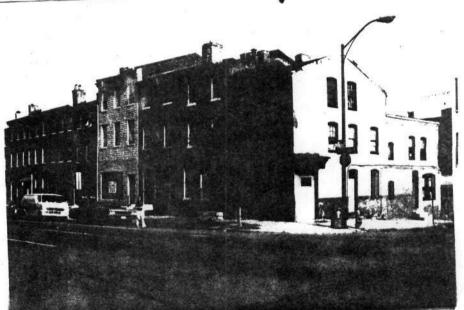
With the exception of 855 (which is now demolished but was earlier) this row dates after 1851 and before the Civil War. Shallow gables, full three stories, fairly wide houses, original store front at 869. The assignment of these to the mid-1850's makes sense on the evidence of details, including doors. Number 863½ has been formstoned.

Lot at 855 has been cleared; there are no vacancies, and maintenance appears high. Opposite a good terrace on Lombard Street. Street is busy, one-way traffic, noisy. More street trees the size of the one at 869 are sorely needed. Elimination of detrimental influences such as the recycling center backing up across Lemmon Street, the derelict houses on Parkin, should help these

good houses to remain so.
